## RED LBP PRE-PURCHASE REPORT

# CERTIFICATE OF INSPECTION IN ACCORDANCE WITH NZS 4306:2005

**Company:** GDDC Ltd trading as RedLBP NC.  
**Client:** Renata and Helio.  
**Date of Inspection:** 24th September 2025  
**Site Address:** 25 Flemington Avenue, North New Brighton, Christchurch 8083  
**Inspector:** Gary Cassidy  
**Qualifications:** Advanced Trade Certificate Carpentry & Joinery. Licenced Building Practitioner.

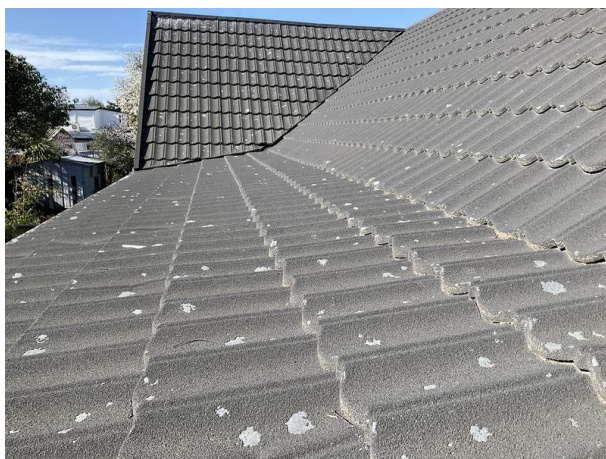
**Photo 4**

Condition of finish - Areas showing deterioration, refer to photos below.

North elevation of roof. Coating deterioration visible.

To maintain the weathertightness of the building, it is important to follow the manufacturer's guidelines for regular maintenance of the roofing system. This may include periodic inspections to identify any signs of damage, such as dents or missing fixings, surface deterioration or leaks. Promptly addressing these issues can prevent further damage and protect the building from the elements.

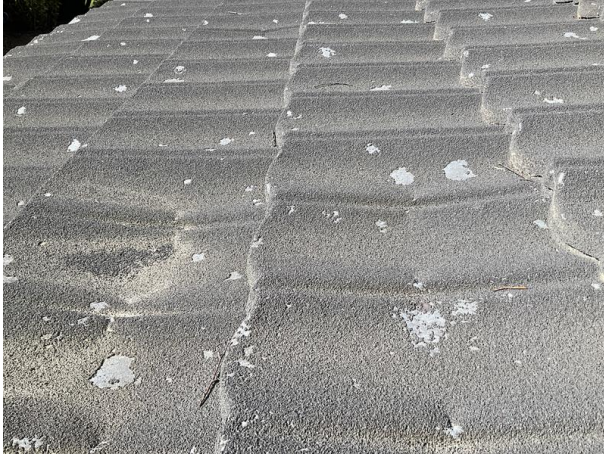
**Photo 5**

Corrosion, damage or dented - Damage or dented tiles visible, refer to the photos below.

Dented roof tiles visible in some areas, repairs or replacement recommended.

Dented tin tiles should be promptly repaired or replaced, as the dents can compromise the protective coating of the tiles. This damage may lead to water ponding, which increases the risk of further deterioration and leaks. It is recommended to engage a Licensed Building Practitioner (LBP) specialising in roofing to carry out any necessary repairs or maintenance beyond the homeowner's expertise, ensuring the work is performed safely and effectively.

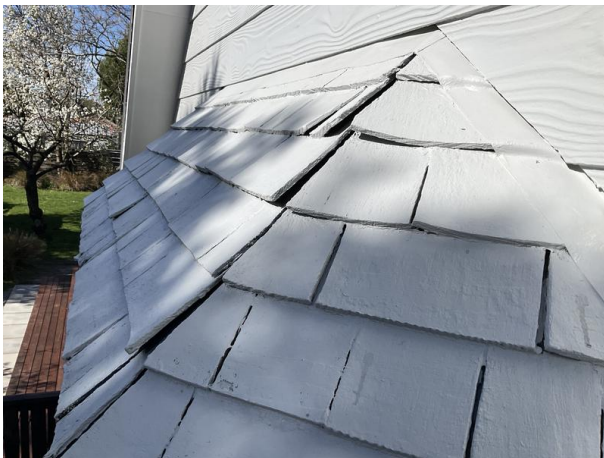
**Photo 6**

Timber shingles over bay windows, monitor and maintain for weathertightness.

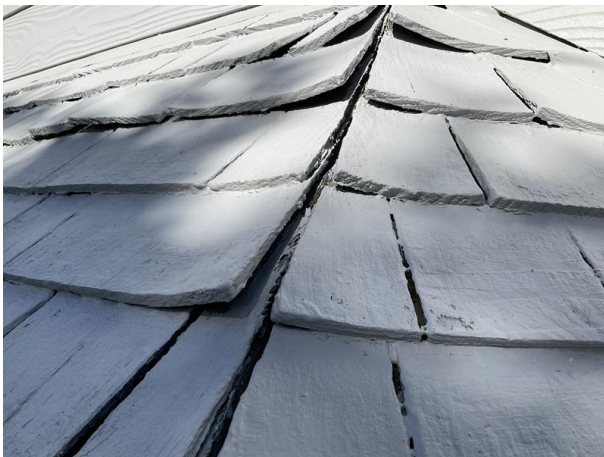
**Photo 7**

No flashing visible on external corner of timber shingles, further investigation recommended.

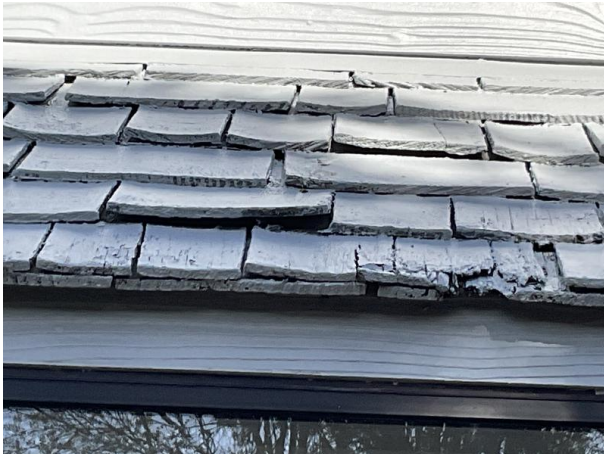
**Photo 8**

Timber shingles over bay windows,  
maintenance recommended to maintain  
for weathertightness.

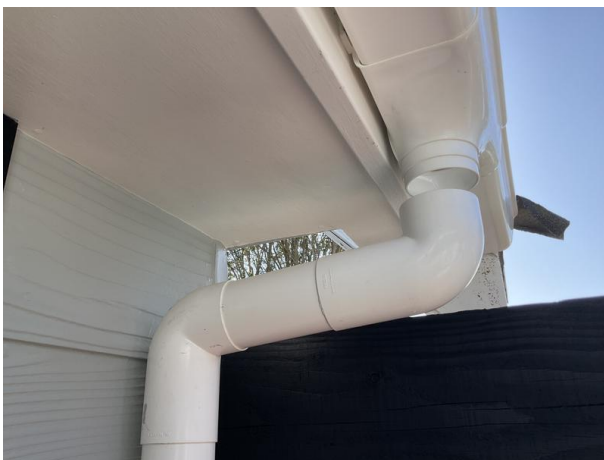
**Photo 12**  
Secure downpipe to dropper on north elevation.

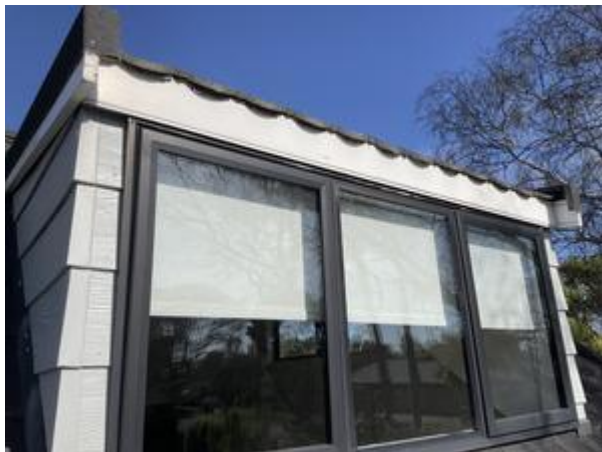
**Photo 16**

Guttering and downpipe recommended for bedroom 4 dormer.

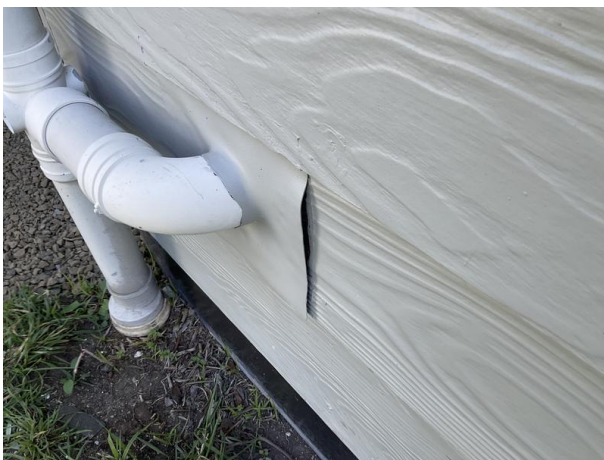
**Photo 19**  
Seal any penetration holes.

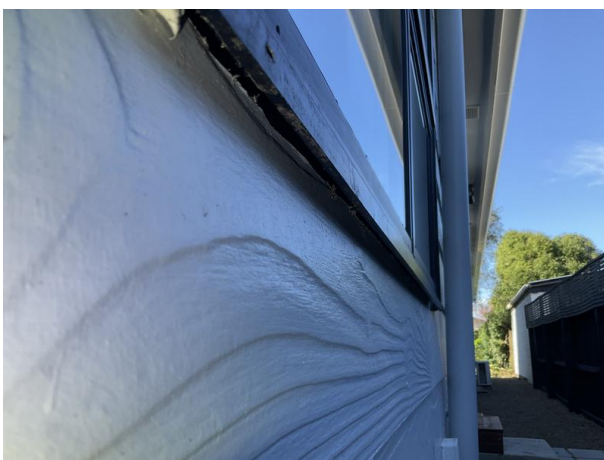
**Photo 22**  
Trim recommended to gap between  
bottom of windows and cladding.

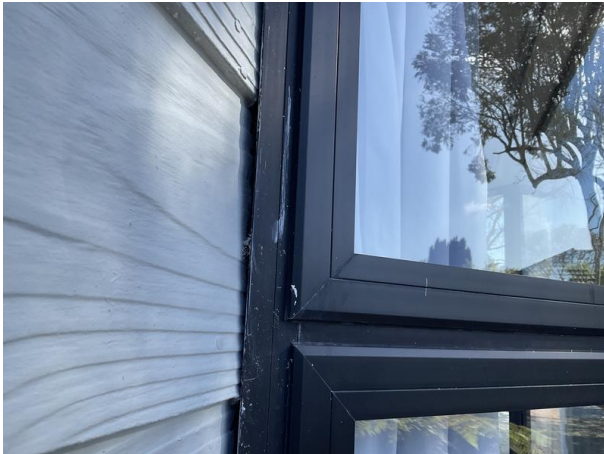
**Photo 28**

Sealant or scribe recommended for window and cladding junction on bay window.

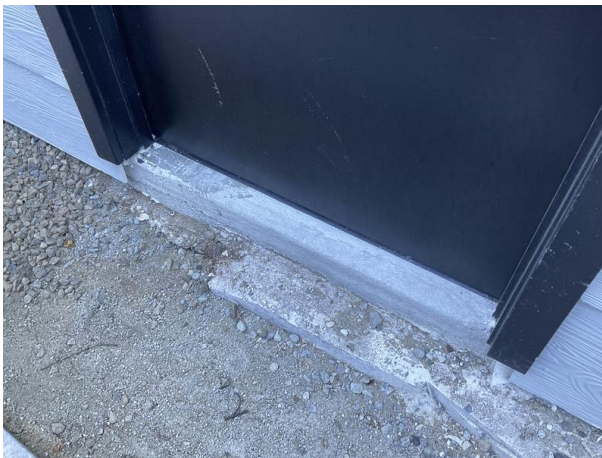
**Photo 32**  
Weatherseal recommended for bottom of garage door on south elevation.

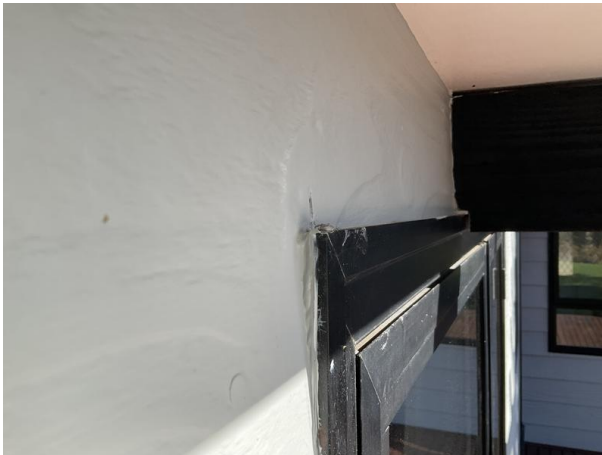
**Photo 33**  
No headflashing visible above bedroom 1 double doors.

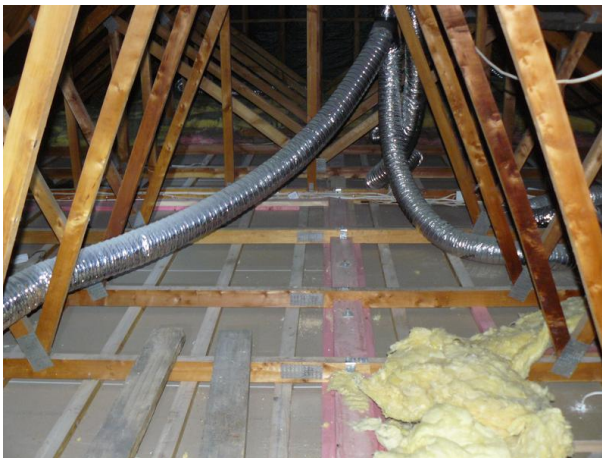
Thickness of insulation visible - Over 200mm. Areas missing insulation.

**Photo 40**  
No insulation over kitchen and living room area.

Certain areas of the property are currently missing insulation, which can compromise the overall energy efficiency and comfort of the home. It is recommended to install insulation in these areas to improve thermal performance, reduce energy consumption, and maintain a consistent indoor temperature. Proper insulation will also contribute to a healthier and more comfortable living environment. Ensure that the installation is carried out in accordance with current standards and guidelines by a qualified professional.

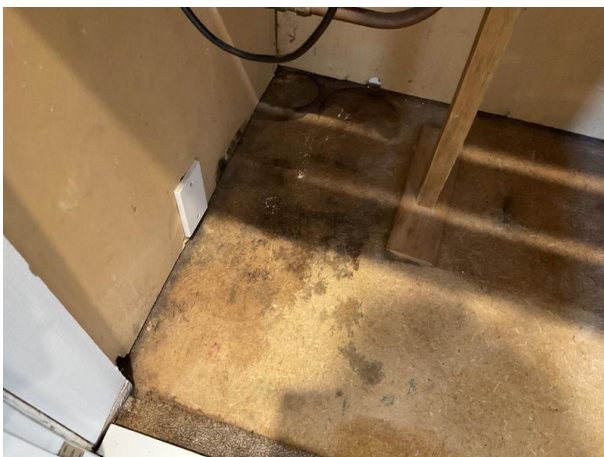
**Photo 53**  
Moisture staining visible under HWC. Dry at the time of the inspection.

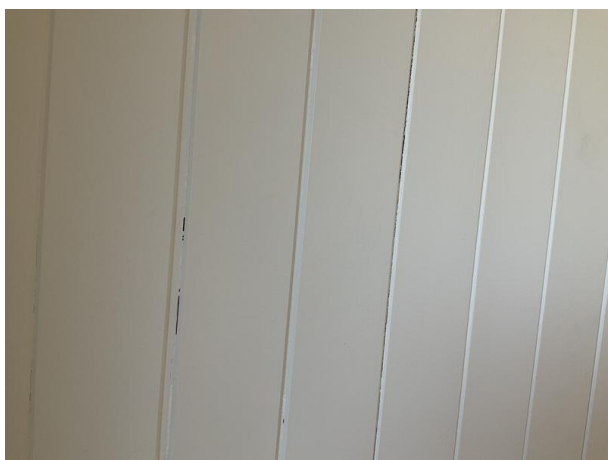
**Photo 58**  
Cosmetic issues to wall.

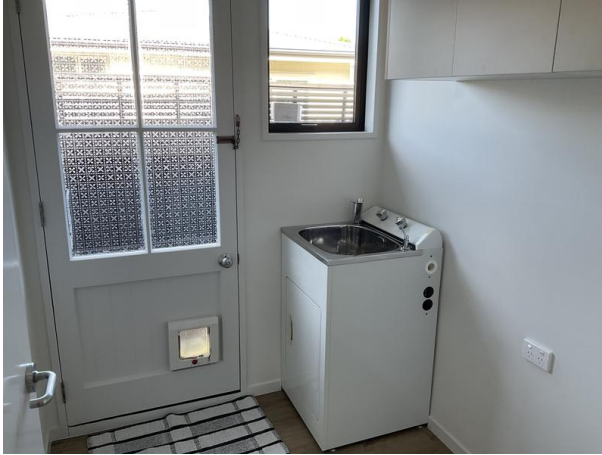
**Photo 59**  
Laundry.

Secure laundry tub to the floor or wall. An unsecured laundry tub can lead to damage of waste pipes causing leaks and subsequent damages.

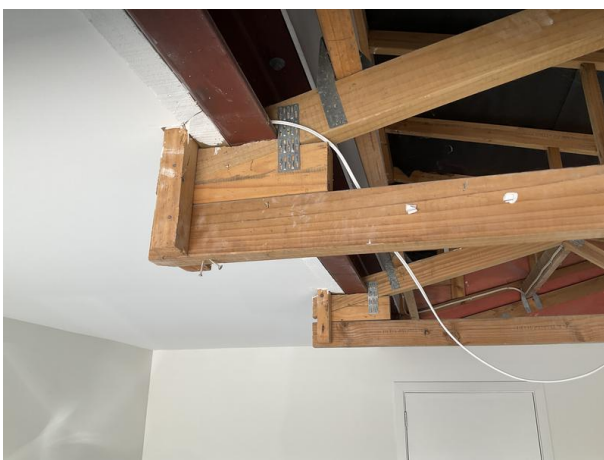
**Photo 63**  
Unusual connection between truss and beam. Monitor.

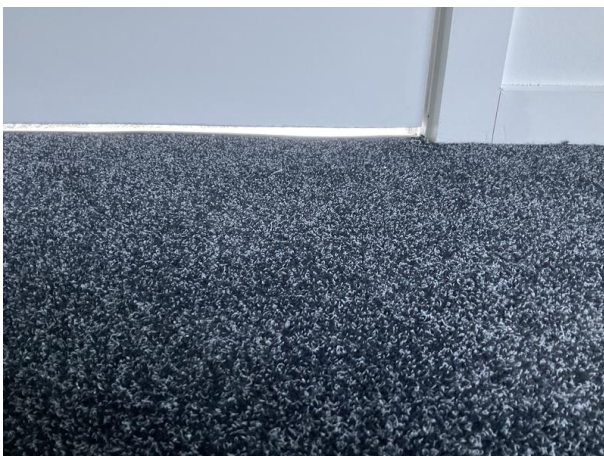
**Photo 64**  
Gap visible under back garage door.  
Weatherseal recommended.

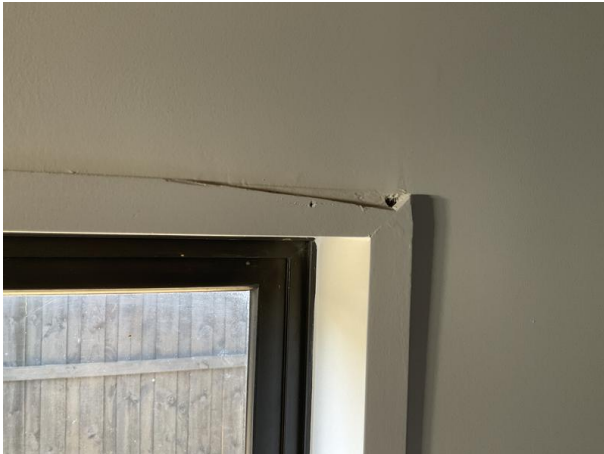
**Photo 65**  
Cosmetic damage to window reveal.

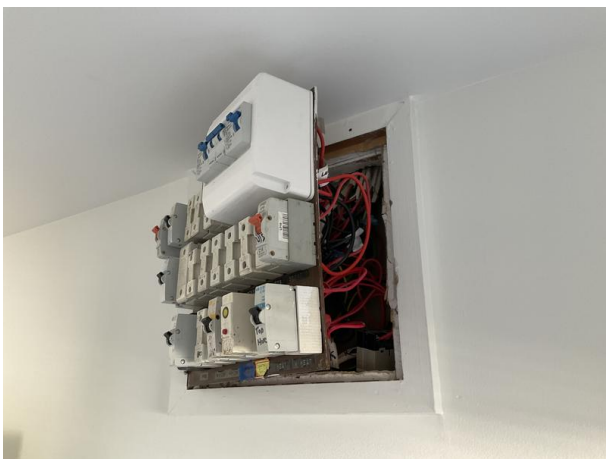
**Photo 76**  
Switchboard needs to be closed, have an electrician rectify.

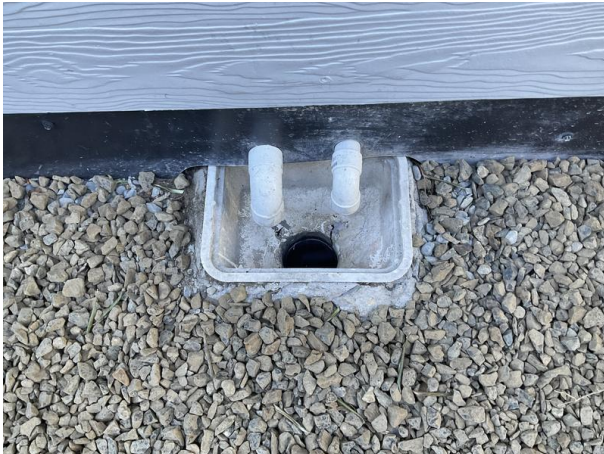
**Photo 85**  
Ensuite gully trap. Grate recommended.
