# FRED #1 LTD

10 SPRINGBURN PLACE, PŌKENO

GEOTECHNICAL ASSESSMENT FOR A PROPOSED  
SUBDIVISION: STAGE 2 (LOTS 13-53)

REFERENCE: R7615-1A  
DATE: 03 NOVEMBER 2021

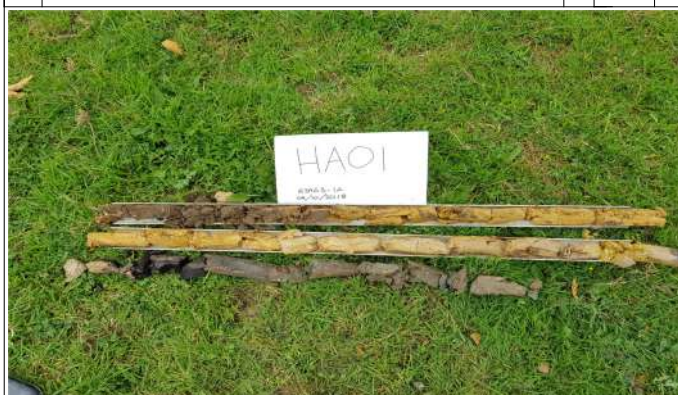
### Investigation Information

Depth 3m      Logged By H.P      Start Date 04/10/18  
Termination Refusal      Checked By F.W      End Date 04/10/18  
Machine Used      Test Pit Dimensions      Logged Date 04/10/18

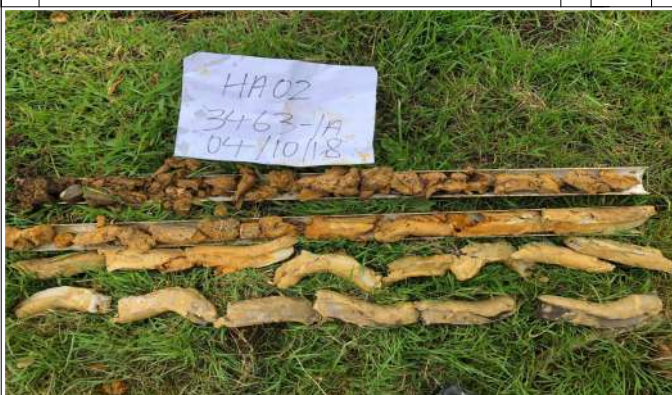
### Investigation Information

Depth 4m      Logged By K.H      Start Date 04/10/18  
 Termination Refusal      Checked By F.W      End Date 04/10/18  
 Machine Used      Test Pit Dimensions      Logged Date 04/10/18

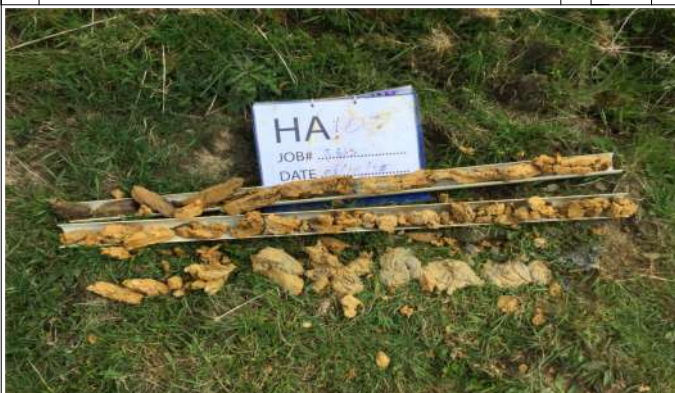
### Investigation Information

Depth 3m      Logged By S.W      Start Date 04/10/18  
 Termination Target depth      Checked By F.W      End Date 04/10/18  
 Machine Used      Test Pit Dimensions      Logged Date 04/10/18

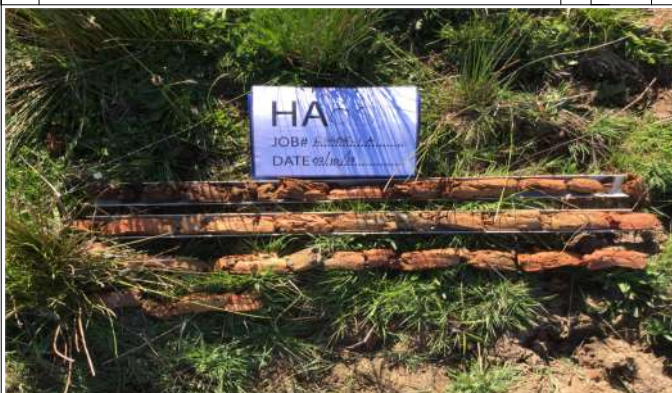
Geology	Geological Interpretation (refer to separate Geotechnical and Geological Information sheet for further information)	Samples	Depth (m)	Legend	Vane Shear Strength				Values (kPa)	Scala Penetrometer						Groundwater				
					Vane No:2089 Vane Size: 19mm					Blows / 100mm										
					50	100	150	200		2	4	6	8	10	12	14	16	18		
ps. 7	TOPSOIL.																			
	Clayey SILT, with minor sand, with trace gravel; dark brownish grey. Mottled orange, brown; light grey & red; dry to moist; low to moderate plasticity; very stiff to hard.																			
	Clayey SILT, with trace sand and gravel; light greyish brown. Very stiff, moderate plasticity; mottled dark brown, brownish grey, red & orange; moist to wet; insensitive.		1																	
Engineered Fill																				
			2																	
			3																	
	End of Investigation: 3.2m Refusal																			
			4

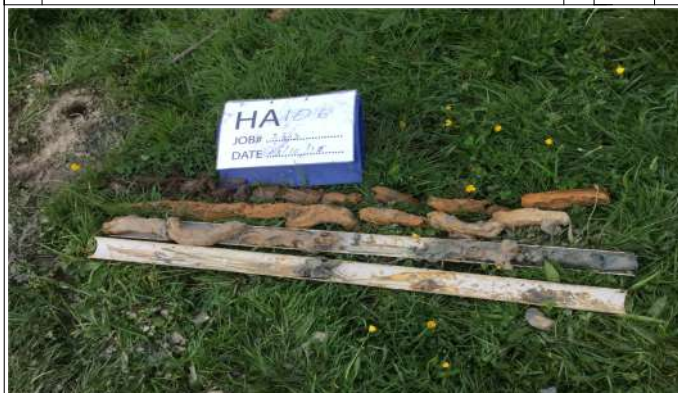
Geology	Geological Interpretation (refer to separate Geotechnical and Geological Information sheet for further information)	Samples	Depth (m)	Legend	Vane Shear Strength				Values (kPa)	Scala Penetrometer						Groundwater				
					Vane No: 1859 Vane Size: 19mm					Blows / 100mm										
					50	100	150	200		2	4	6	8	10	12	14	16	18		
Topsoil	TOPSOIL.																			
	Weathered Ash	SILT; light brown. Very stiff; low plasticity; moist; insensitive.							146											
		Clayey SILT; light orange. Very stiff; low plasticity; moist; mottled white; insensitive.	1						93											
ALLUVIAL DEPOSITS	CLAY, with minor silt; light grey. Stiff; high plasticity; wet; moderately sensitive to sensitive.							86												
								21												
	Clayey SILT, with some sand. Low plasticity; wet; stiff to very stiff; moderately sensitive to sensitive.	2							70											
									26											
								69

23												
								140												
								54												
								130												
								37												
								141												
								32												
	End of Investigation: 4m Target depth		4

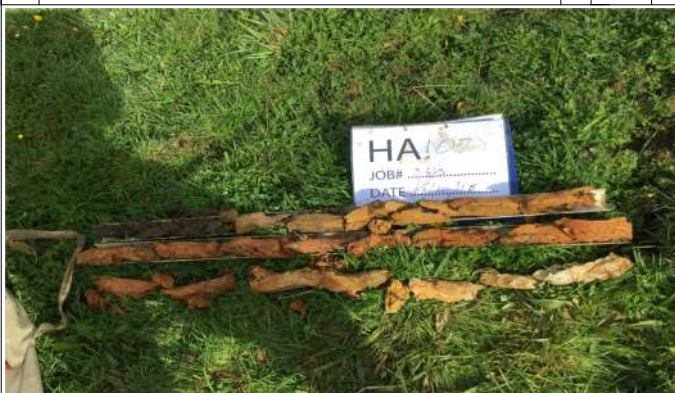
Geology	Geological Interpretation (refer to separate Geotechnical and Geological Information sheet for further information)	Samples	Depth (m)	Legend	Vane Shear Strength				Values (kPa)	Scala Penetrometer (Blows / 100mm)						Groundwater	
					Vane No: 1859 Vane Size: 19mm					2	4	6	8	10	12		14
Topsoil	TOPSOIL.			TS													
Weathered Ash	Clayey SILT; light orange. Very stiff; low plasticity; moist; insensitive.								153								
									113								
	Clayey SILT; light reddish orange. Very stiff; moderate plasticity; moist; insensitive.		1						141								
									111								
	Clayey SILT, with minor sand; light grey. Very stiff; low plasticity; moist; insensitive.		2						122								
									101								
									137								
									71								
									140								
									93								
	End of Investigation: 3m Target depth		3						168								
									97								
			4

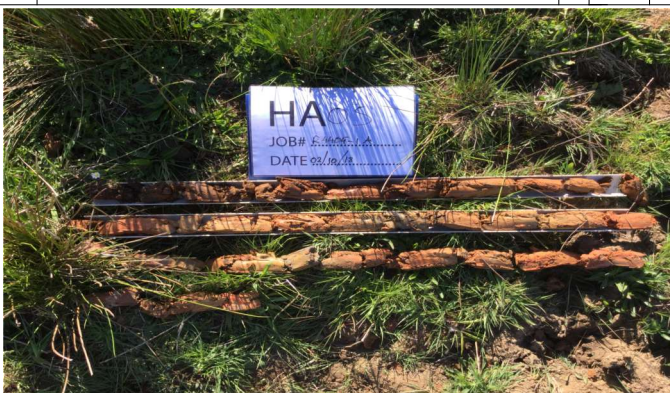
Geology	Geological Interpretation <small>(refer to separate Geotechnical and Geological Information sheet for further information)</small>	Samples	Depth (m)	Legend	Vane Shear Strength				Values (kPa)	Scala Penetrometer <small>(Blows / 100mm)</small>						Groundwater			
					<small>Vane No:2089 Vane Size: 19mm</small>					2	4	6	8	10	12		14	16	18
TOPSOIL.	Clayey SILT, with minor sand, with trace gravel; dark brownish grey. Mottled orange, brown; light grey & red; dry to moist; low to moderate plasticity; very stiff to hard.																		
Engineered Fill	Clayey SILT, with trace sand and gravel; light greyish brown. Very stiff, moderate plasticity; mottled dark brown, brownish grey, red & orange; moist to wet; insensitive.		1						>211

-									
										151									
										121									
										181									
										138									
										>211									
										-									
										163									
										129									
	End of Investigation: 3.2m Refusal		2						138										
									99										
										198									
										149									
										181									
										167									
	End of Investigation: 3.2m Refusal		3						144										
									105										
										135									
								91											
								144											
								93											
			4

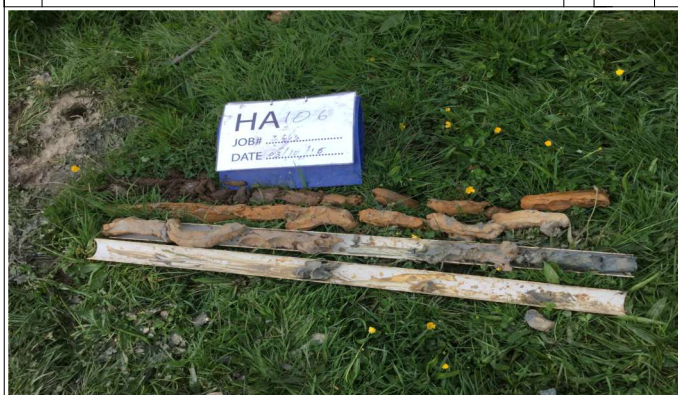
Geology	Geological Interpretation (refer to separate Geotechnical and Geological Information sheet for further information)	Samples	Depth (m)	Legend	Vane Shear Strength				Values (kPa)	Scala Penetrometer						Groundwater				
					Vane No: 1859 Vane Size: 19mm					Blows / 100mm										
					50	100	150	200		2	4	6	8	10	12	14	16	18		
Topsoil	TOPSOIL.																			
Weathered Ash	SILT; light brown. Very stiff; low plasticity; moist; insensitive.								146											
	Clayey SILT; light orange. Very stiff; low plasticity; moist; mottled white; insensitive.		1						75											
ALLUVIAL DEPOSITS	CLAY, with minor silt; light grey. Stiff; high plasticity; wet; moderately sensitive to sensitive.								93											
	Clayey SILT, with some sand. Low plasticity; wet; stiff to very stiff; moderately sensitive to sensitive.		2						60											
									86											
									21											
			3						70

26											
									69											
									23											
									140											
									54											
									130											
									37											
									141											
			4						32											
	End of Investigation: 4m Target depth

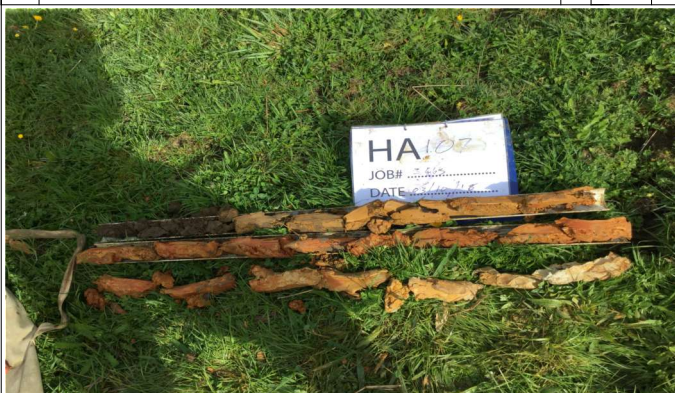
Geology	Geological Interpretation (refer to separate Geotechnical and Geological Information sheet for further information)	Samples	Depth (m)	Legend	Vane Shear Strength				Values (kPa)	Scala Penetrometer (Blows / 100mm)						Groundwater	
					Vane No: 1859 Vane Size: 19mm					2	4	6	8	10	12		14
Topsoil	TOPSOIL.			TS													
Weathered Ash	Clayey SILT; light orange. Very stiff; low plasticity; moist; insensitive.								153								
									113								
	Clayey SILT; light reddish orange. Very stiff; moderate plasticity; moist; insensitive.		1						141								
									111								
	Clayey SILT, with minor sand; light grey. Very stiff; low plasticity; moist; insensitive.		2						122								
									101								
			3						137								
									71								
									140								
									93								
	End of Investigation: 3m Target depth		3						168								
									97								
			4

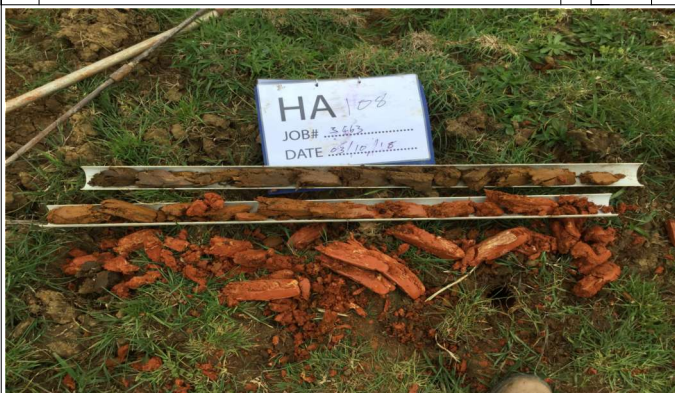
Geology	Geological Interpretation (refer to separate Geotechnical and Geological Information sheet for further information)	Samples	Depth (m)	Legend	Vane Shear Strength		Values (kPa)	Scala Penetrometer (Blows / 100mm)							Groundwater		
					Vane No: 1859	Vane Size: 19mm		2	4	6	8	10	12	14		16	18
Topsoil	TOPSOIL.			TS													
FILL	Clayey SILT, with some topsoil; dark brownish orange. Low plasticity; moist.						109										
							71										
Weathered Ash	Clayey SILT; light brown. Low plasticity; moist; very stiff to hard; insensitive.  1.6m: Becoming red.  2.4m: Becoming red mottled white.  End of Investigation: 3m Target depth						115										
							86										
		1					>196										
								175									
						104											
			2				>196										
							-										
							>196										
							-										
			3				171										
							99										
			4

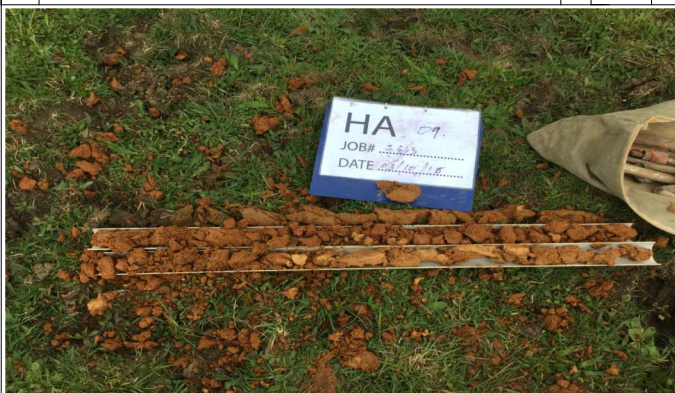
Geology	Geological Interpretation (refer to separate Geotechnical and Geological Information sheet for further information)	Samples	Depth (m)	Legend	Vane Shear Strength				Values (kPa)	Scala Penetrometer (Blows / 100mm)							Groundwater		
					Vane No:2088 Vane Size: 19mm					2	4	6	8	10	12	14		16	18
Topsoil	TOPSOIL.			TS															
Weathered Ash	Clayey SILT; brownish orange. Hard; moderate plasticity; moist.								>188										
	Clayey SILT, with trace sand; yellowish orange. Very stiff; moderate plasticity; mottled reddish orange; moist to wet; insensitive.		1						169										
	Silty CLAY, with trace sand; light yellow. Very stiff; mottled brownish orange; moist to wet; moderate to high plasticity; insensitive.								153										
	<b>End of Investigation: 3m Target depth</b>		3						158										
									119										
			4

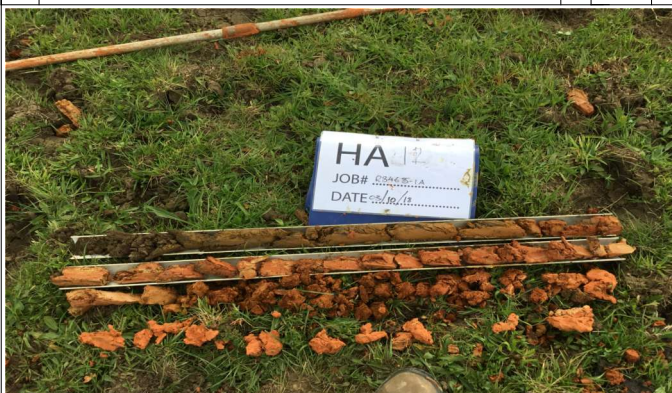
Geology	Geological Interpretation (refer to separate Geotechnical and Geological Information sheet for further information)	Samples	Depth (m)	Legend	Vane Shear Strength				Values (kPa)	Scala Penetrometer (Blows / 100mm)							Groundwater
					Vane No:2089 Vane Size: 19mm					2	4	6	8	10	12	14	
Topsoil	TOPSOIL.			TS													
	Clayey SILT, with trace sand; brownish orange. Very stiff; moist; mottled greyish brown; low to moderate plasticity; insensitive.																
Weathered Ash	Clayey SILT, with minor sand; light red. Very stiff; moderate plasticity; mottled orange & white; moist to wet; insensitive.		1						187								
	Clayey SILT, with some sand; brownish grey. Very stiff; high plasticity; mottled red; moist to wet; insensitive.		2						151								
	Silty CLAY, with some clay; dark red. Very stiff; low plasticity; wet; mottled dark brownish orange & black; insensitive.								124

Clayey SILT; light red. Stiff; wet; moderate to high plasticity; low core recovery; insensitive.		3						76								
	Clayey SILT, with some sand; light red. Hard; moderate plasticity; wet; mottled light orange & white.								136								
	End of Investigation: 4m Target depth		4						205

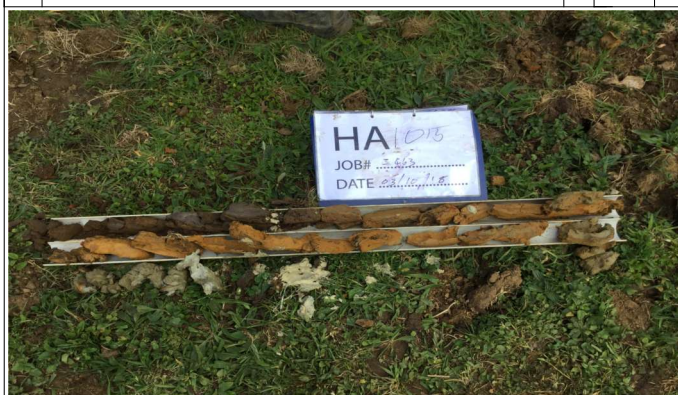
Geology	Geological Interpretation (refer to separate Geotechnical and Geological Information sheet for further information)	Samples	Depth (m)	Legend	Vane Shear Strength				Values (kPa)	Scala Penetrometer						Groundwater				
					Vane No: 1859 Vane Size: 19mm					Blows / 100mm										
					50	100	150	200		2	4	6	8	10	12	14	16	18		
Topsoil	TOPSOIL and colluvium intermixed; some mineralisation			TS					126											
ALLUVIAL DEPOSITS	Clayey SILT, with some sand; light orange. Very stiff; low plasticity; moist; insensitive.		1						122											
	CLAY, with minor silt; light orange. High plasticity; moist; very stiff; insensitive.								133											
			2						140											
									120											
	2.4m: no/poor core recovery.								71											
	End of Investigation: 3m Target depth		3						115											
									78											
			4

SWL  
2.20m

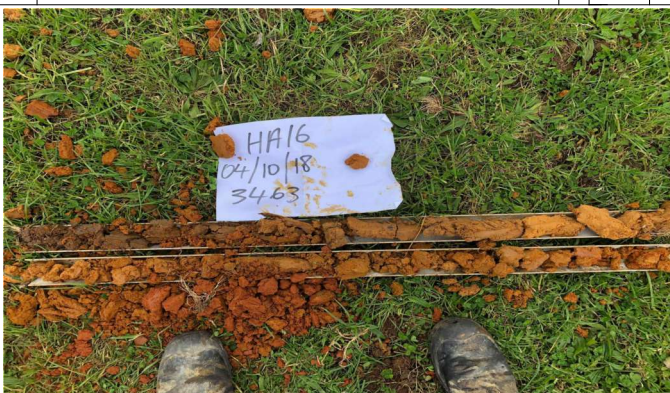
Geology	Geological Interpretation (refer to separate Geotechnical and Geological Information sheet for further information)	Samples	Depth (m)	Legend	Vane Shear Strength				Values (kPa)	Scala Penetrometer (Blows / 100mm)						Groundwater	
					Vane No:2088 Vane Size: 19mm					2	4	6	8	10	12		14
Topsoil	TOPSOIL.			TS													
Weathered Ash	Clayey SILT; brownish orange. Moderate plasticity; moist; very stiff to hard; insensitive.							165									
	SILT, with trace sand; red. Hard; low plasticity; moist; mottled brownish orange.		1					>188									
	<b>End of Investigation: 2m Target depth</b>		2					>188									
			3														
			4

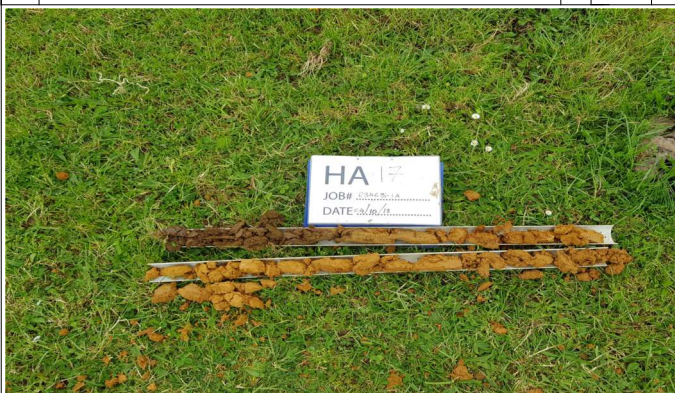
Geology	Geological Interpretation (refer to separate Geotechnical and Geological Information sheet for further information)	Samples	Depth (m)	Legend	Vane Shear Strength				Values (kPa)	Scala Penetrometer (Blows / 100mm)							Groundwater	
					Vane No:2089 Vane Size: 19mm					2	4	6	8	10	12	14		16
Topsoil	TOPSOIL.																	
	Clayey SILT, with trace sand; brownish orange. Very stiff; moderate plasticity; moist; mottled orange; moderately sensitive.								192									
Weathered Ash	Clayey SILT, with trace sand; light brownish orange. Very stiff; moist to wet; low to moderate plasticity.		1						169									
									97									
									178									
									137									
	SILT, with some clay, with minor sand; brownish orange. Very stiff; low plasticity; moist; insensitive.		2						181									
	<b>End of Investigation: 2m Target depth</b>								102									
			3															
			4

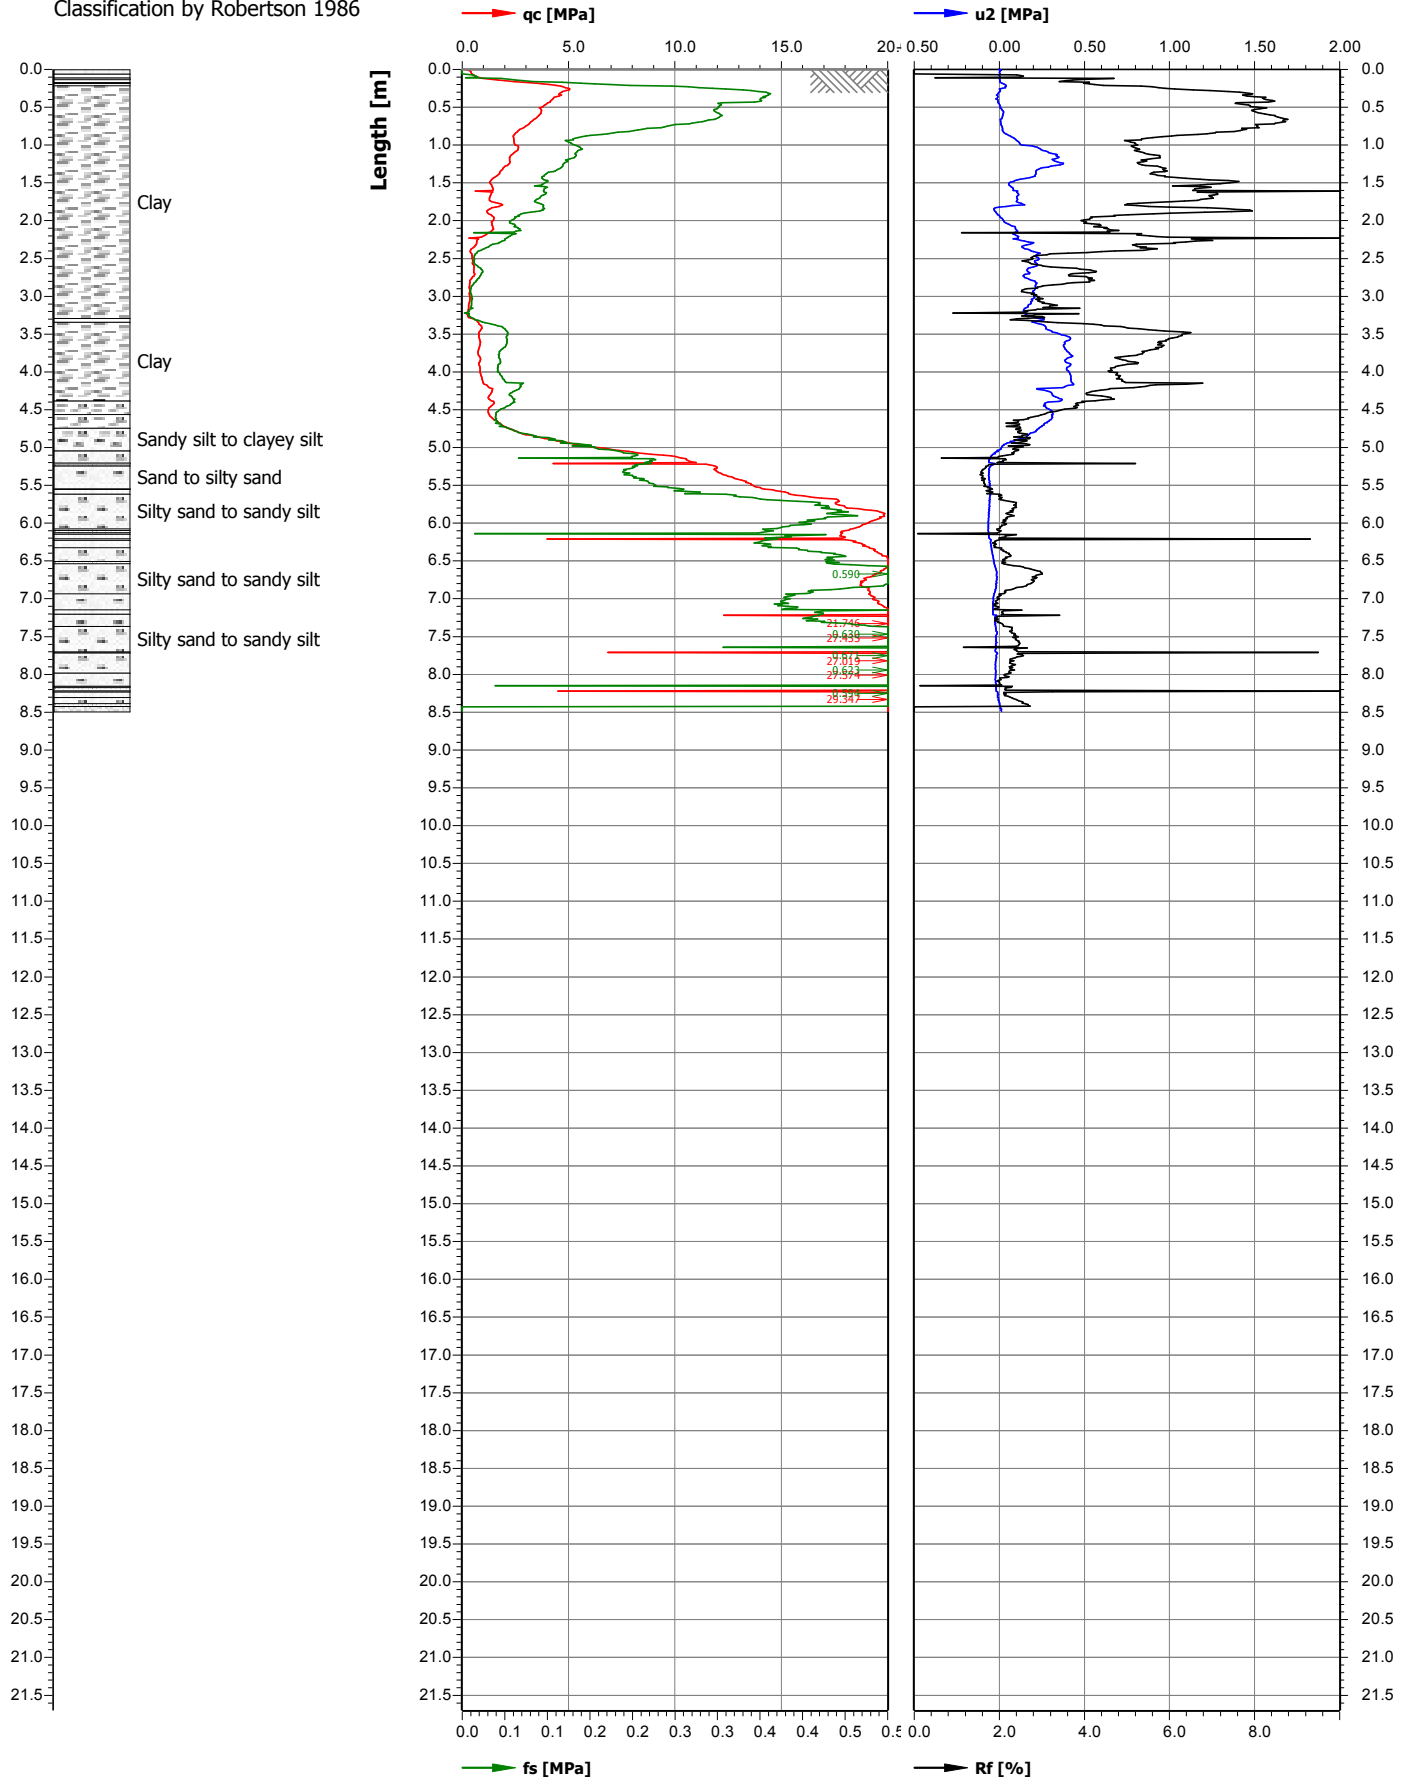
Project name	GCLHelensvaleCrescent		Date investigation	9/03/2020	
	Test name	CPT03		Cone name	S10CFIIP.1734	
Test location name	Client	Ground Consulting LTD		Net surface area quotient of ...	0.850/0.000	Nominal surface area of cone...
X coordinate [m]/Y coordinat...	Project contractors	0.00/0.00		Fig. no.:		
Z value [m]	Project engineer	0.00		Scale	1:100	Page
Remarks1

Classification by Robertson 1986

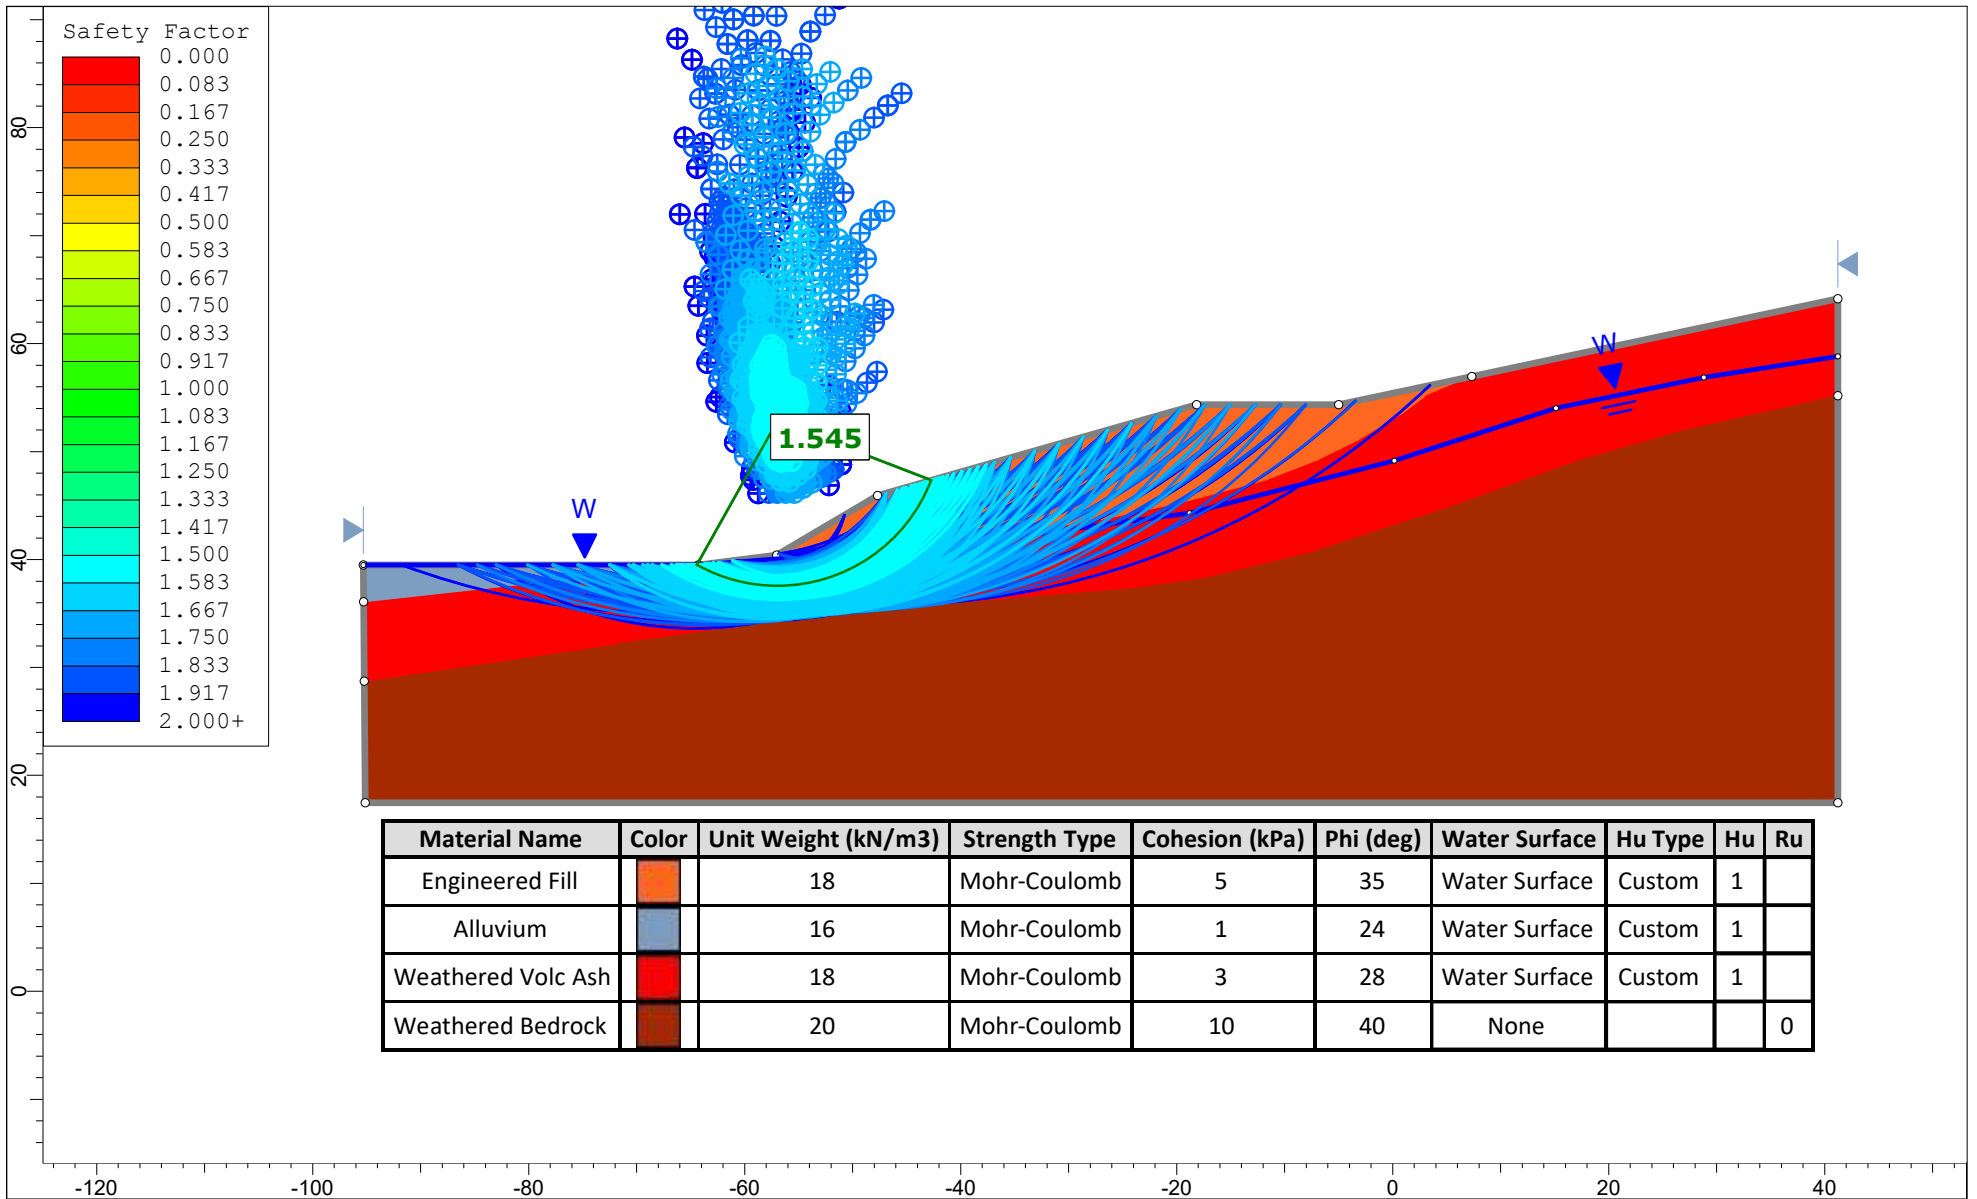
Project		R7615-1A Cross-Section A-A'	
	Group		Proposed Subdivision Profile	Scenario
	Drawn By		LK	Company
	Date		17/11/2021, 9:06:17 AM	File Name
			Winter Groundwater Condition	
			GCL	
			R7615-1A-Cross-section A.slmd

Material Name	Color	Unit Weight (kN/m3)	Strength Type	Cohesion (kPa)	Phi (deg)	Water Surface	Hu Type	Hu	Ru
Engineered Fill		18	Mohr-Coulomb	5	35	Water Surface	Custom	1	
Alluvium		16	Mohr-Coulomb	1	24	Water Surface	Custom	1	
Weathered Volc Ash		18	Mohr-Coulomb	3	28	Water Surface	Custom	1	
Weathered Bedrock		20	Mohr-Coulomb	10	40	None			0
