EQC CLAIM DOCUMENTATION

EARTHQUAKE RECOVERY (EQR) DOCUMENTATION

EQR Property Overview Report

EQC Property ID	Property Address	Vulnerable?	Property F Status	Property Finalisation Indicator		
2010103171	148 HOON HAY ROAD, HOON HAY		F3 - Complete & Finalised	Some Finalisation has taken place		
Main Contractor:	CLOSED OUT-Watts & Hughes Construction Limited ***** (SB72)		Property F2'd By:	Lorcan Grogan	F2 Completed Date:	04-12-2014
Cont Managing Hub:	<MULTIPLE>	Not Vulnerable	Property F3'd By:	Philip Lever	F3 Completed Date:	07-01-2015

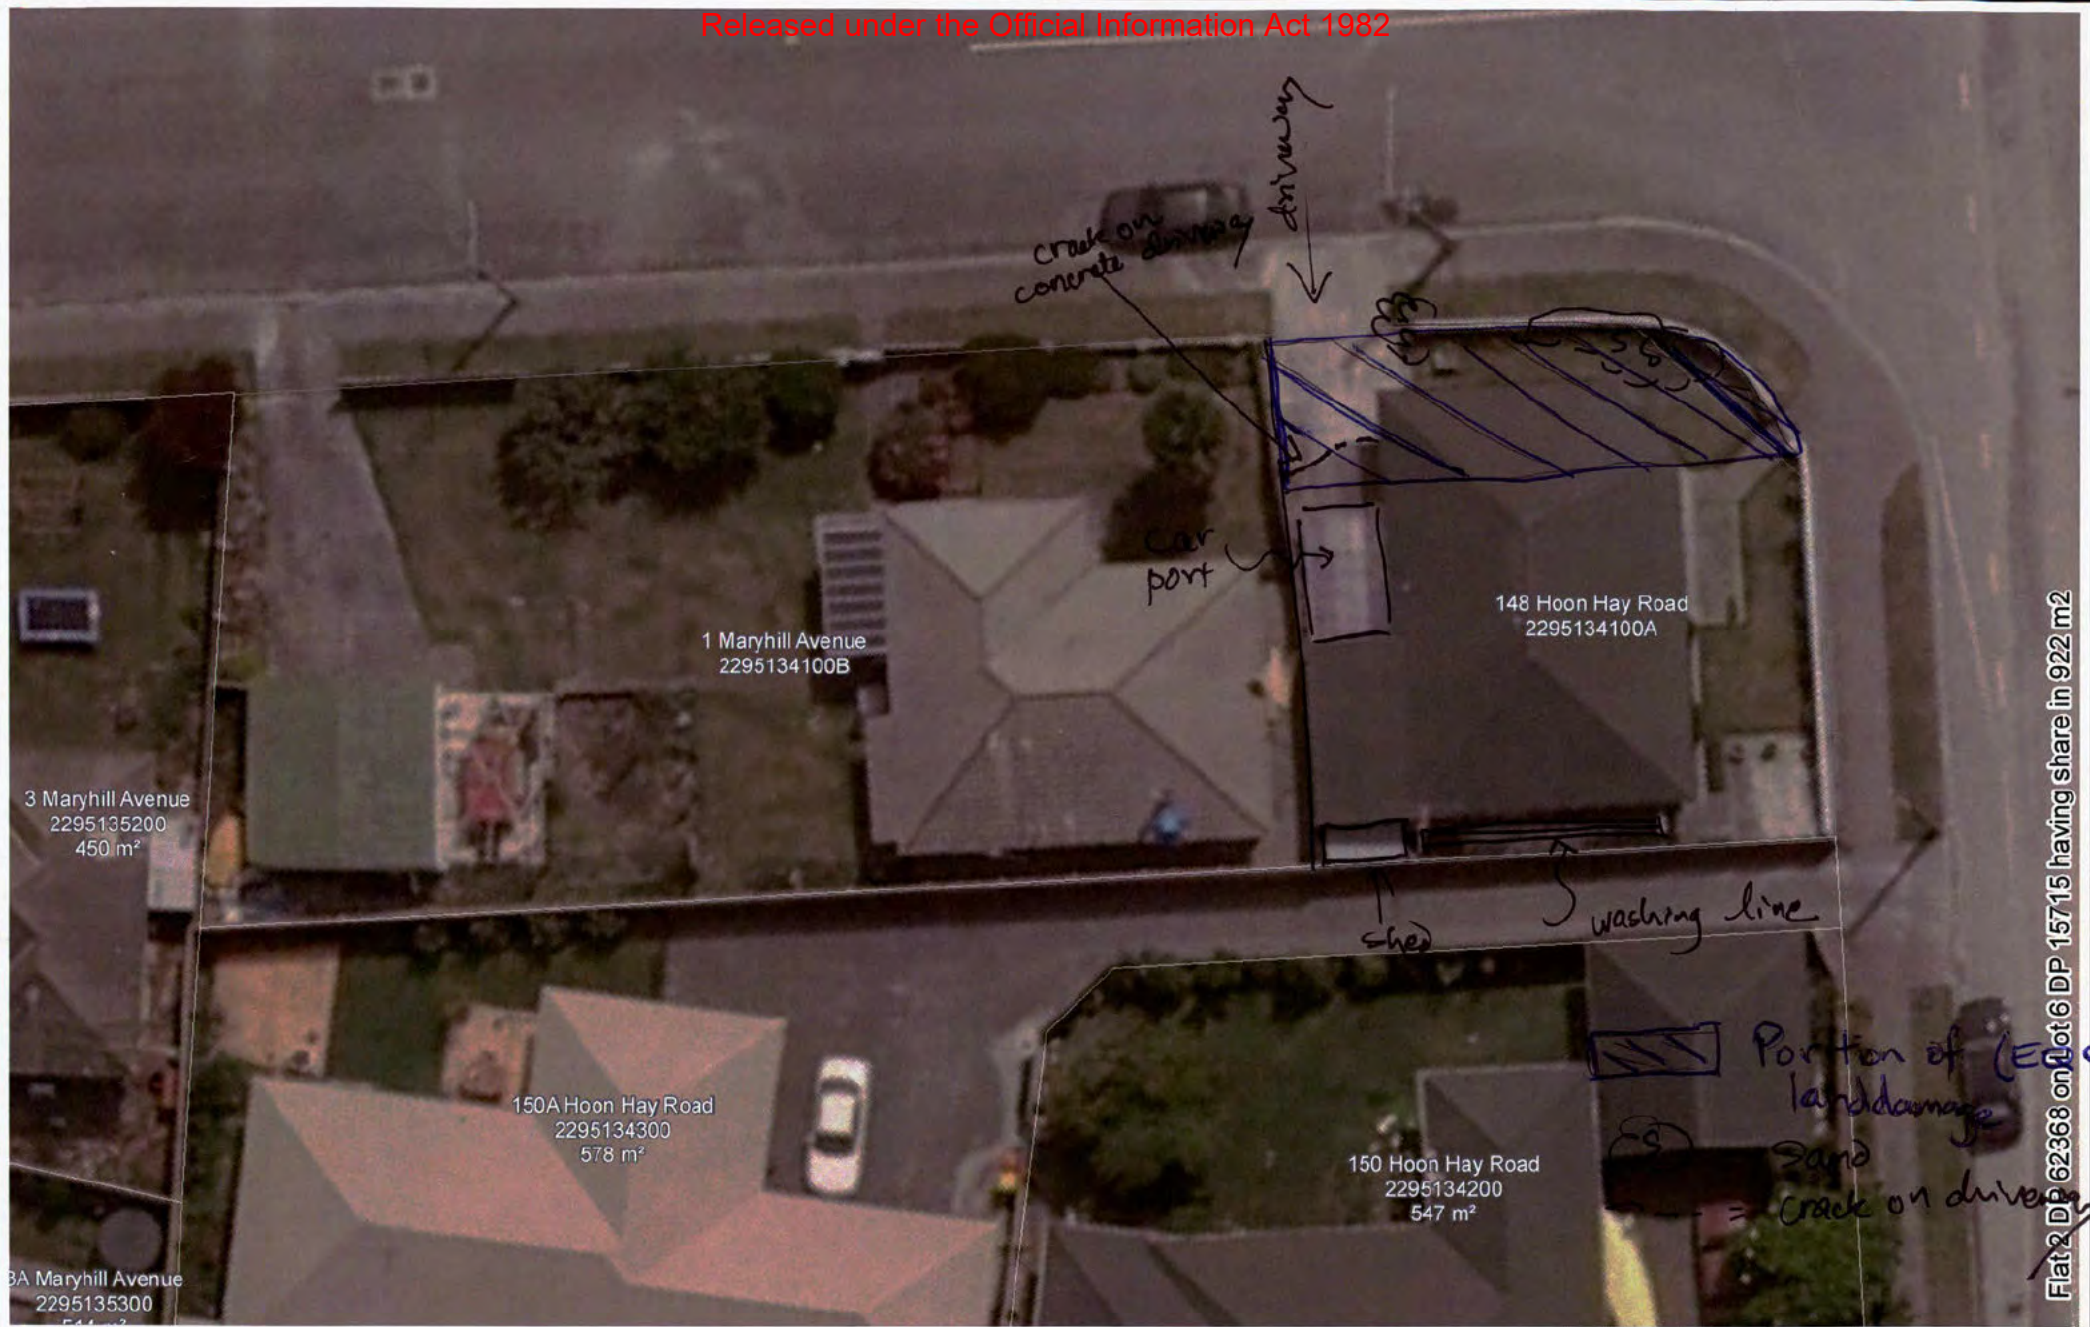
Flat 2 DP 62368 on Lot 6 DP 15715 having share in 922 m2

Notes: EQC Portion = $12 \times 5 + \frac{1}{2} \times 5 \times 5 = 75 \text{ m}^2$

Maximum EQC Insured Area <i>295</i> m ²
