## RED LBP PRE-PURCHASE REPORT

# CERTIFICATE OF INSPECTION IN ACCORDANCE WITH NZS 4306:2005

**Company:** GDDC Ltd trading as RedLBP NC.  
**Client:** Renata and Helio.  
**Date of Inspection:** 24th September 2025  
**Site Address:** 25 Flemington Avenue, North New Brighton, Christchurch 8083  
**Inspector:** Gary Cassidy  
**Qualifications:** Advanced Trade Certificate Carpentry & Joinery. Licenced Building Practitioner.

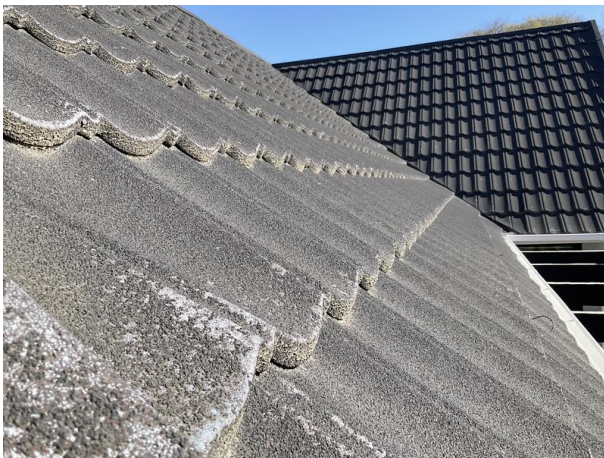
**Photo 9**

North elevation of roof. Coating deterioration visible.

North elevation of roof.

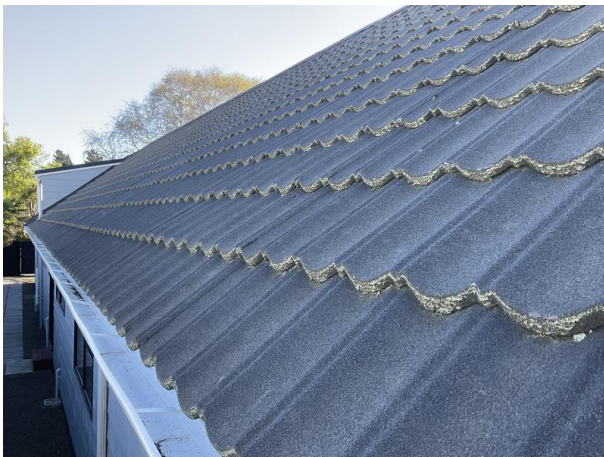
**Photo 10**

South elevation of roof.

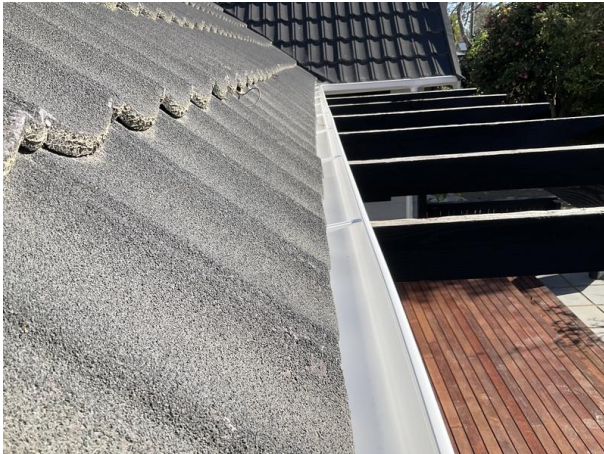
**Photo 11**  
Gutters were clear at time of the inspection.

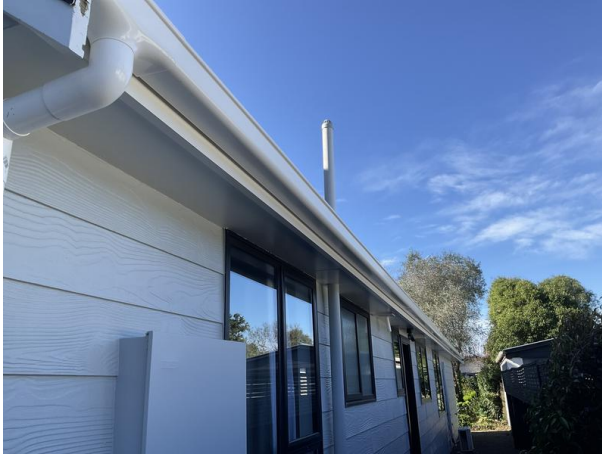
**Photo 14**

Only one outlet on long run on south elevation.

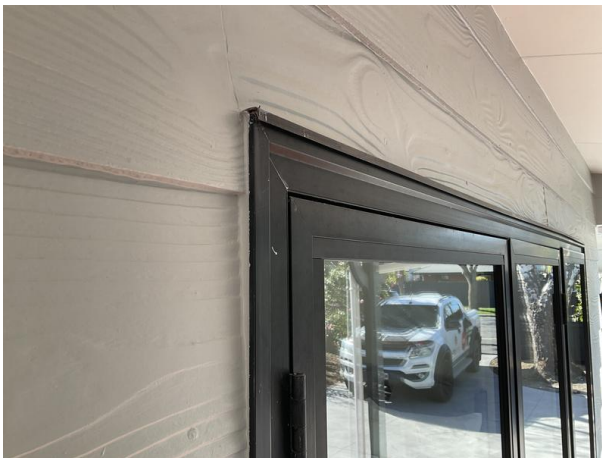
**Photo 26**

Head flashing visible above windows and doors.

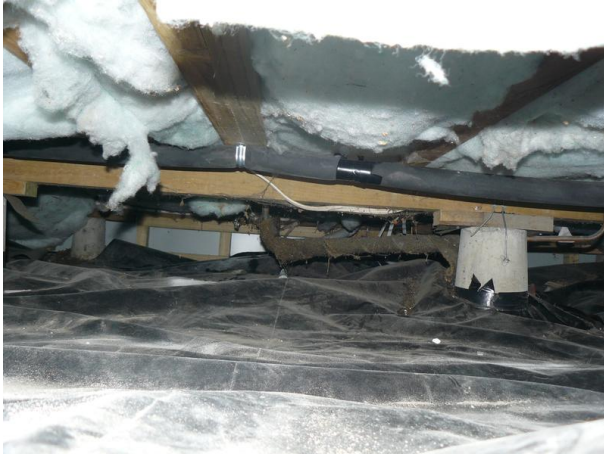
**Photo 35**

Subfloor, concrete piles connected to timber bearers and joists with polyester insulation. Plumbing and waste pipes visible under bathroom.

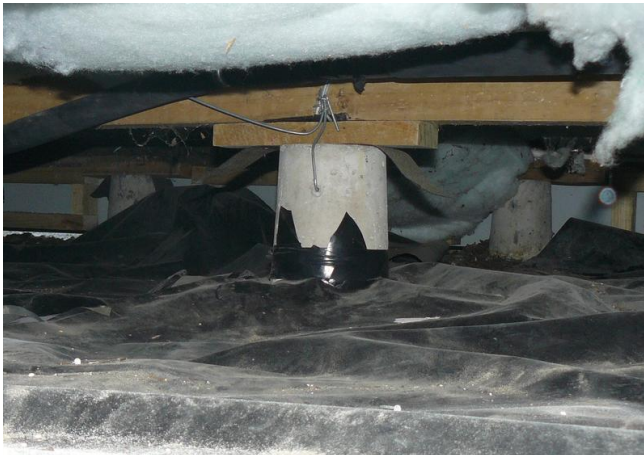
**Photo 37**

Subfloor, timber packers and pile to bearer connection visible.

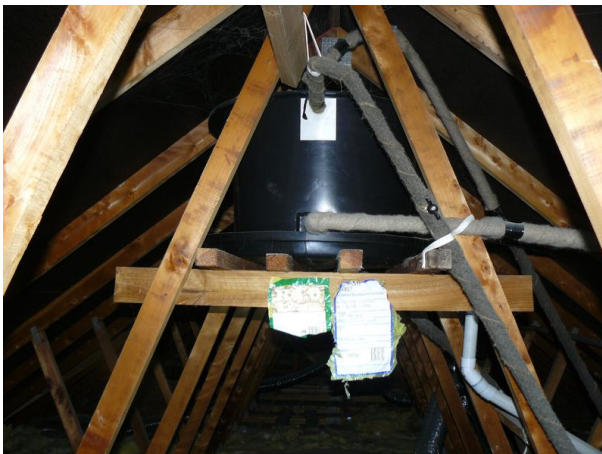
**Photo 41**  
Header tank at apex of roof space.

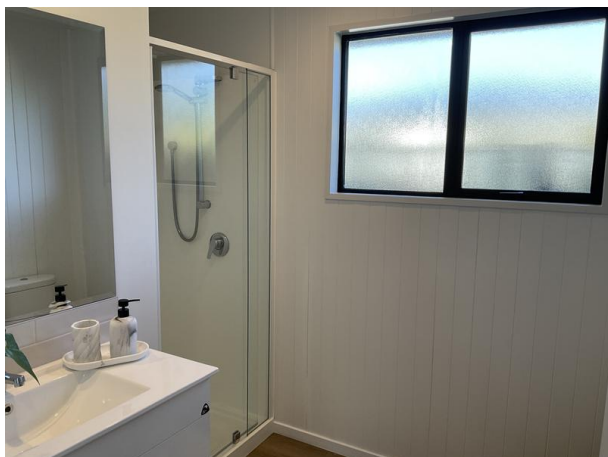
**Photo 57**  
Bathroom.

Ceiling linings - Plasterboard - Paint finished.  
Ceiling wall junction - Scotia.  
Wall linings - Plasterboard and timber - Paint finished.  
Wall defects - Cosmetic issues.  
Exterior joinery - Aluminium - Double-glazed - Safety glass - Painted timber reveals.  
Internal doors - Hollow core.  
Floor covering - Vinyl planking.  
Cistern & pan - Floor mounted. Tested - Functional - Yes. No visible issues.  
Single or dual flush - Dual.  
Vanity - Wall mounted.  
Taps and waste - Functional - Yes.  
Leakage - None visible at the time of the inspection.  
Type of plumbing - uPVC waste and braided wire.  
Splashback - Tiled - Sealed edge.  
Bath - Not applicable.  
Shower - Enclosure. No visible moisture issues.  
Glass type - Safety.  
Shower pressure - Adequate.  
Water hammer - No noise or vibration noted.  
Leaks from shower fittings - No.  
Mechanical ventilation - Functional - Yes. Externally vented - Yes.

Heating - Yes.  
Heated towel rail - Yes.  
Defects - Refer to photos.

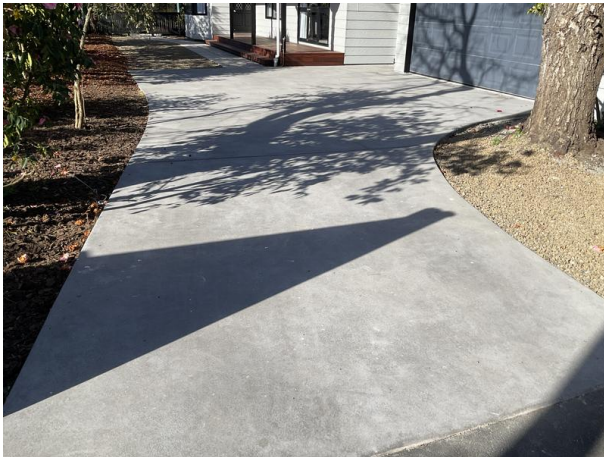
Coloured concrete.  
Cracking - None visible.

**Photo 66**  
Concrete driveway.

General upkeep and maintenance of driveway by cleaning and keeping free of debris.

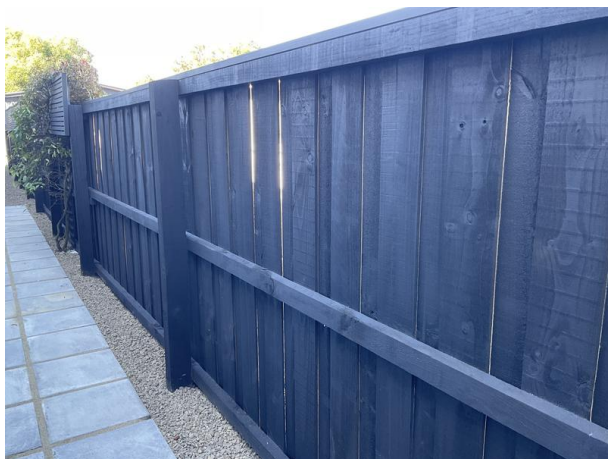
**Photo 67**  
South boundary fence.

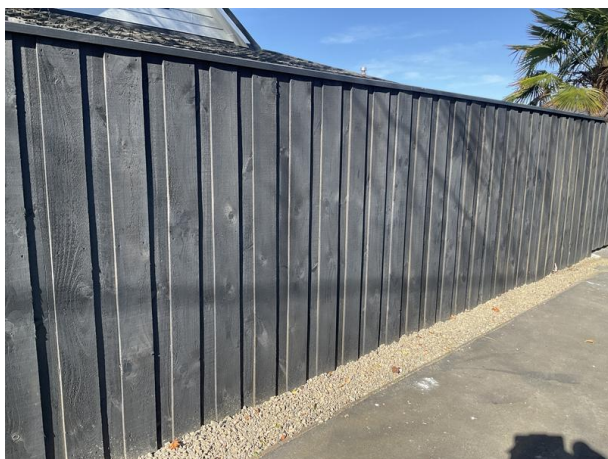
**Photo 68**  
West boundary fence.

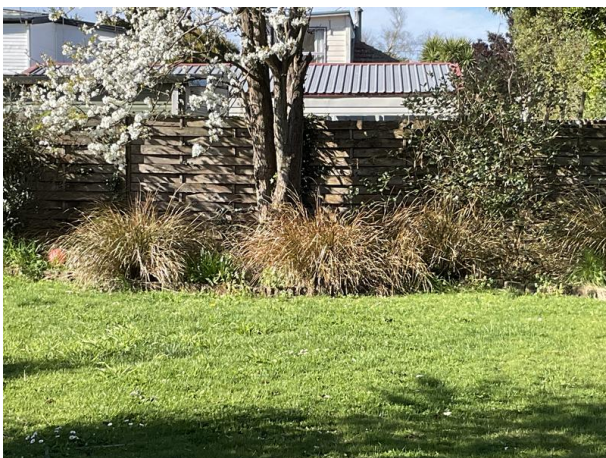
**Photo 70**  
East boundary fence.

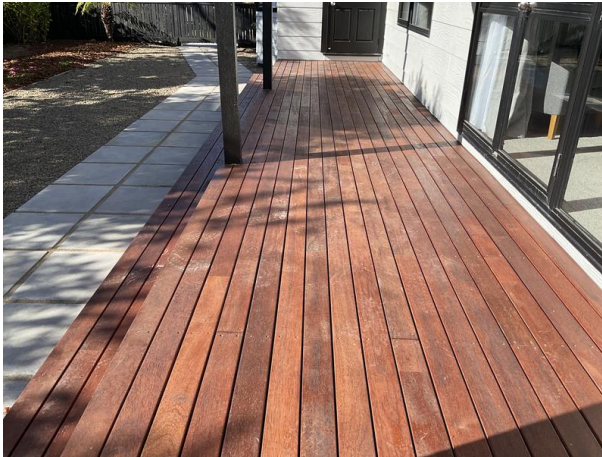
**Photo 73**

Timber deck on north elevation under verandah.

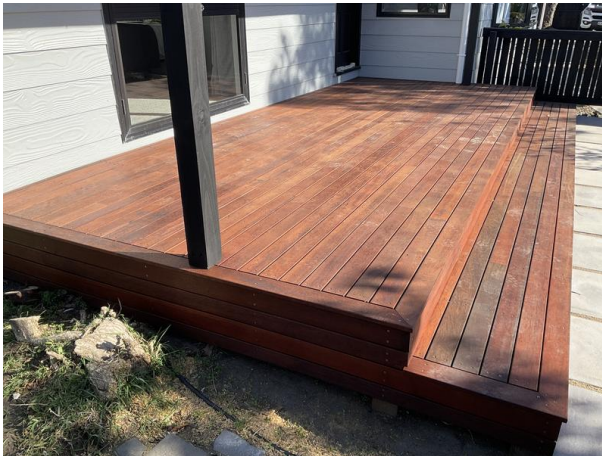
**Photo 74**

Timber deck on north elevation access from bedroom 1 and back entrance.

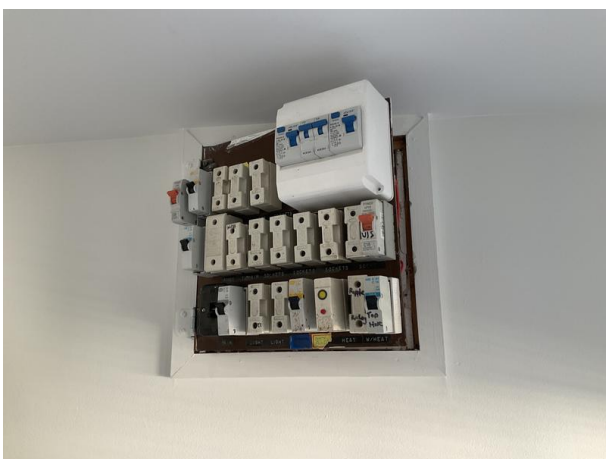
**Photo 75**  
Switchboard in laundry.

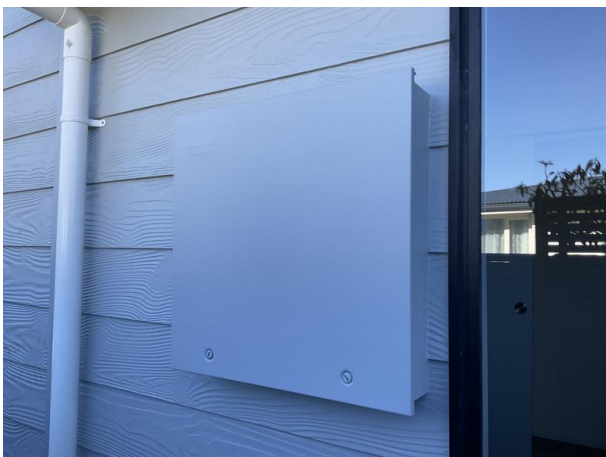
**Photo 77**  
Meter box on south elevation.

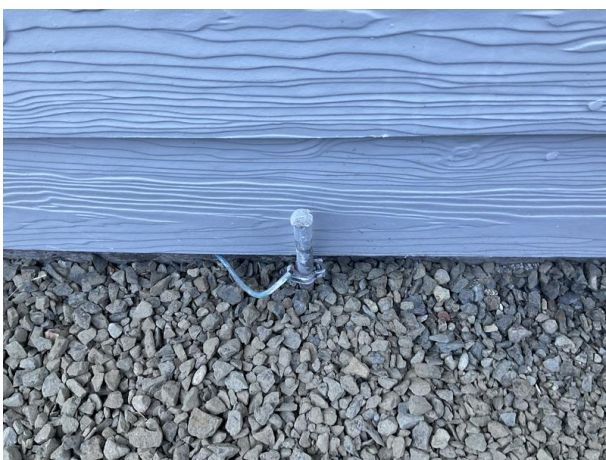
**Photo 78**  
Earth stake connection on south elevation.

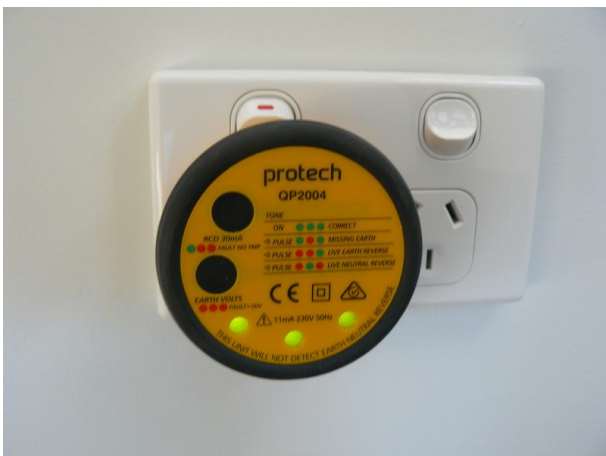
**Photo 79**  
All accessible socket were tested.

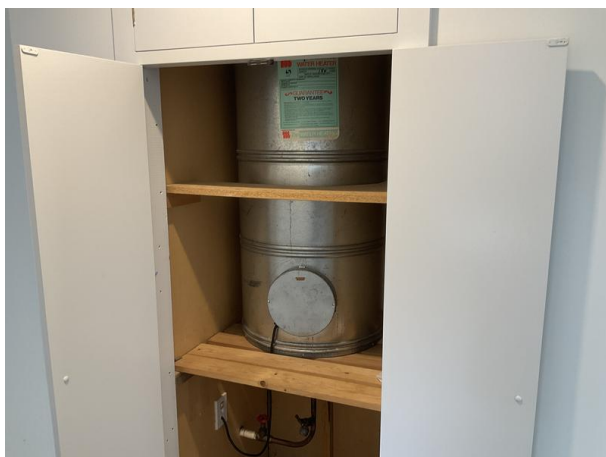
**Photo 80**  
HWC in hallway cupboard.

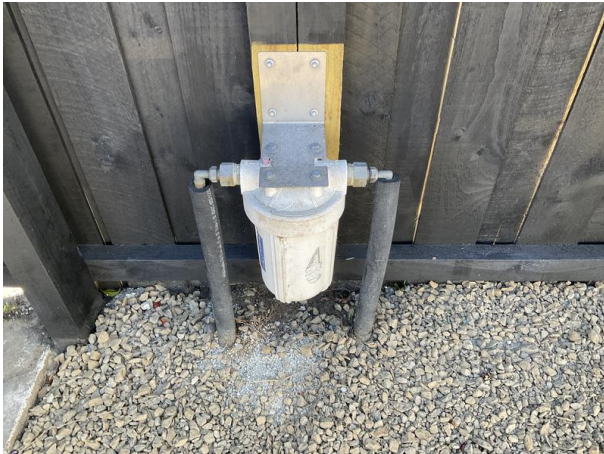
**Photo 82**  
Water filters on west boundary.

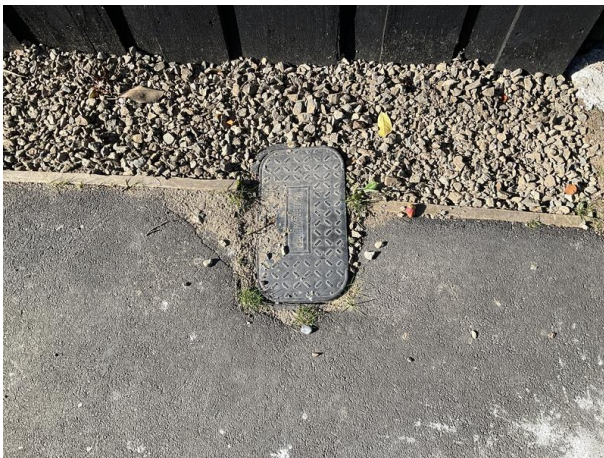
**Photo 83**  
Toby box is located centrally on the west boundary.

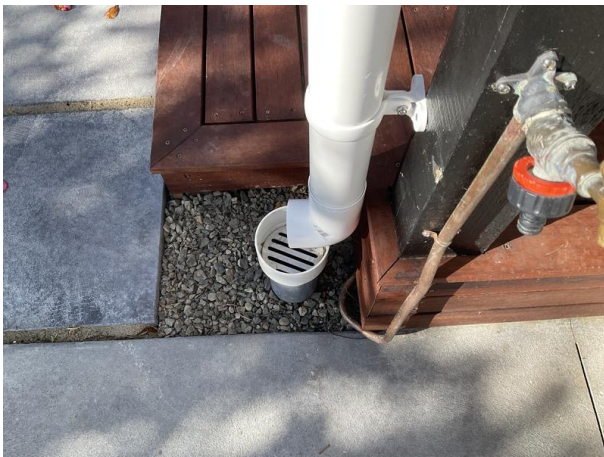
**Photo 84**  
Stormwater riser and downpipe.

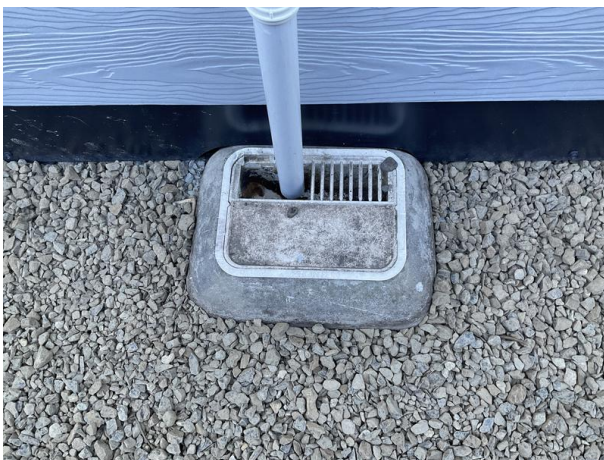
**Photo 86**  
Kitchen gully trap.

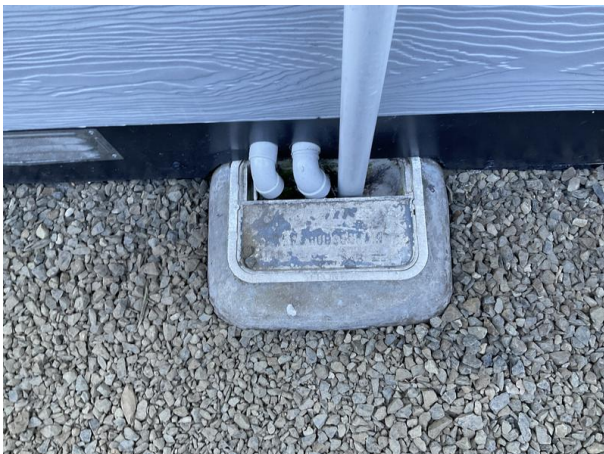
**Photo 87**  
Bathroom and laundry gully trap.

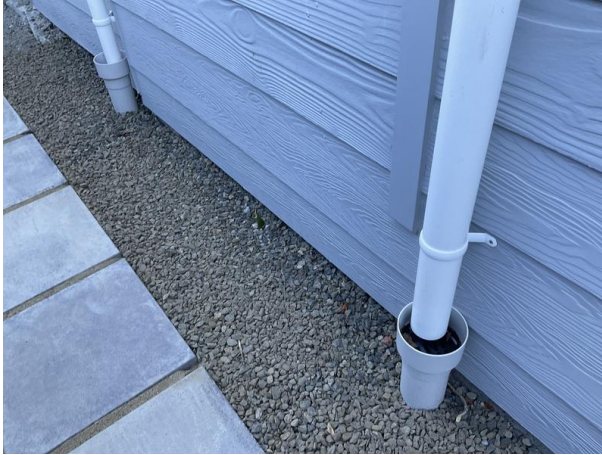
**Photo 88**

Stormwater risers and downpipes.

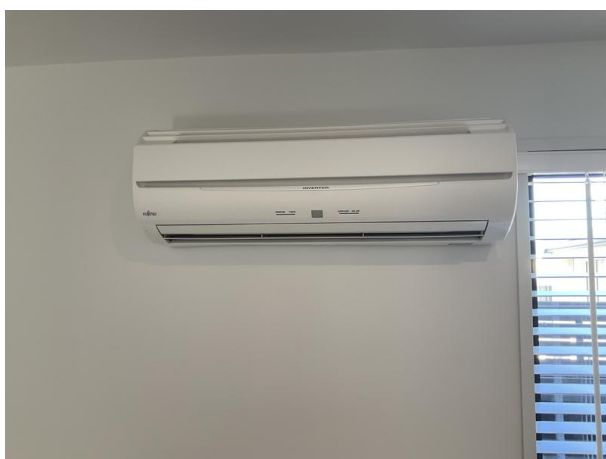
**Photo 89**

Heat pump inside unit in dining room.

Regularly clean the filters of your heat pump to maintain optimal performance. The frequency of cleaning depends on the unit's location and usage, typically ranging from every 4 to 12 weeks. Units placed in areas with higher dust or debris accumulation may require more frequent cleaning, while those in cleaner environments may need less frequent maintenance. This ensures efficient operation.

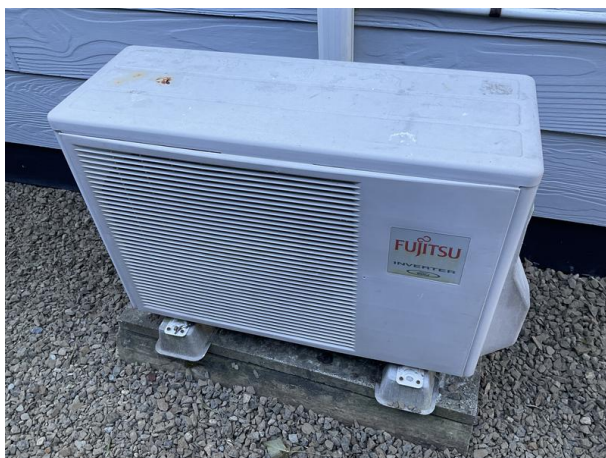
**Photo 90**

Heat pump outside unit.

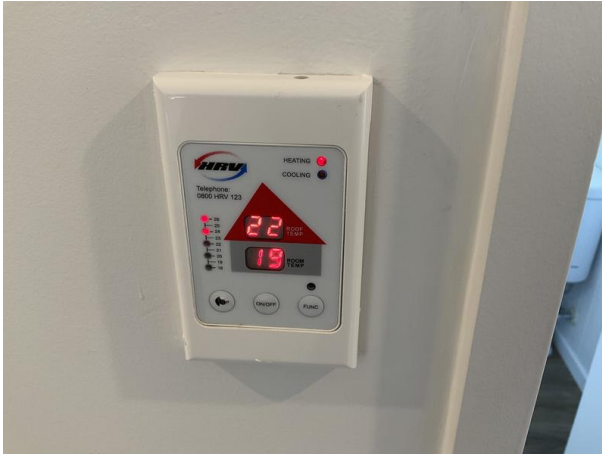
**Photo 91**  
HRV controller in hallway.

Ventilation system filters should be inspected annually and replaced periodically or as required by the manufacturer.

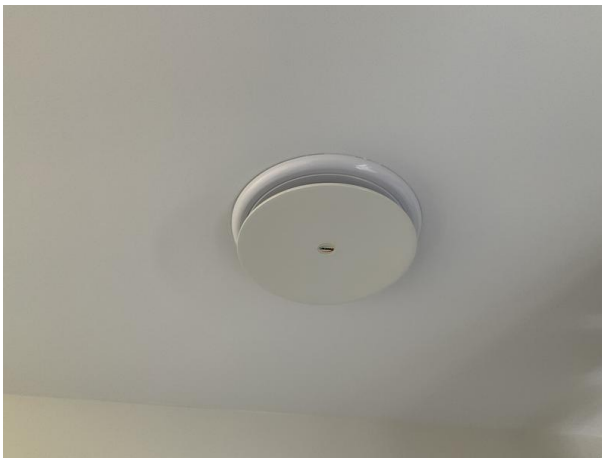
**Photo 92**  
Ventilation system vent on ceiling.

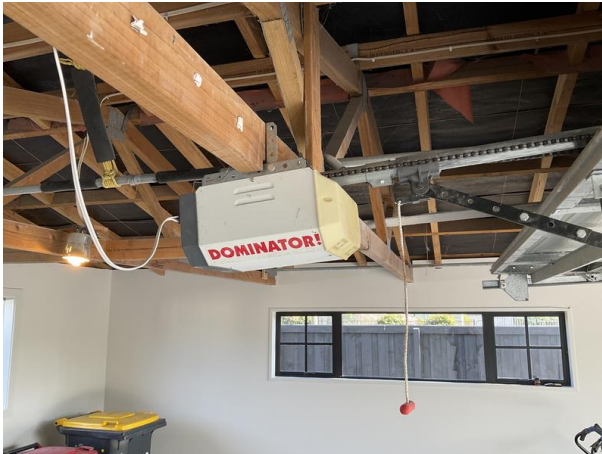
**Photo 93**  
Garage door opener operational.

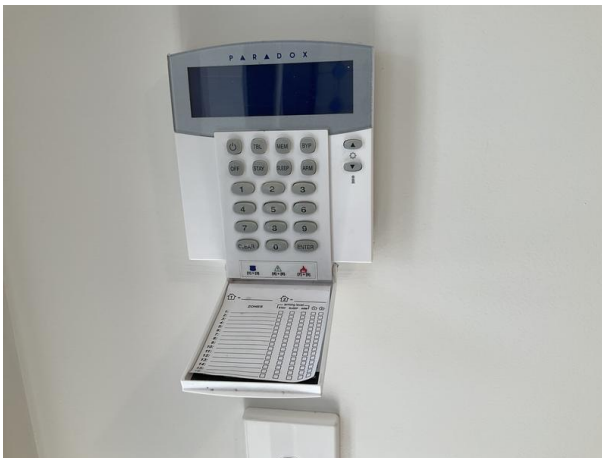
**Photo 94**  
Security key pad in entrance.

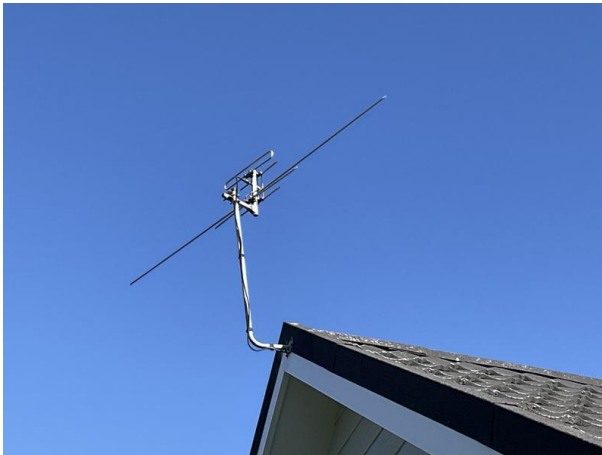
**Photo 95**  
TV aerial on east elevation.

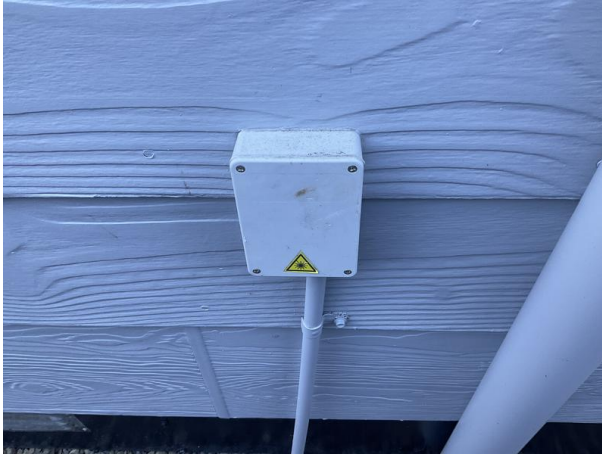
**Photo 96**  
Internet connection on south elevation.

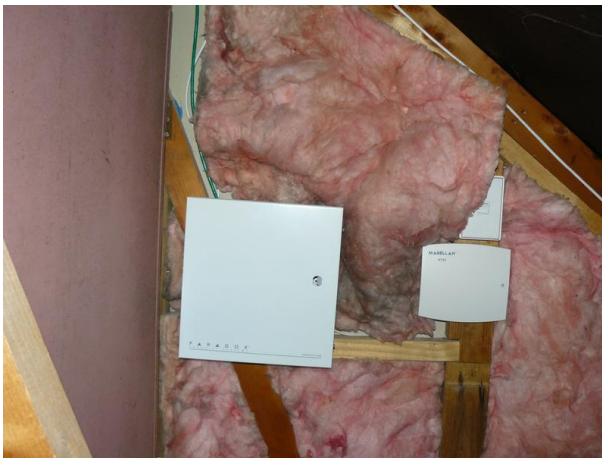
**Photo 97**  
Security box in roof space.
